WHEN “GOOD” IS TOO GOOD

Brian Hattery
Planning & Engineering Supervisor
Transmission Field Services
American Electric Power
Columbus, OH

Abstract

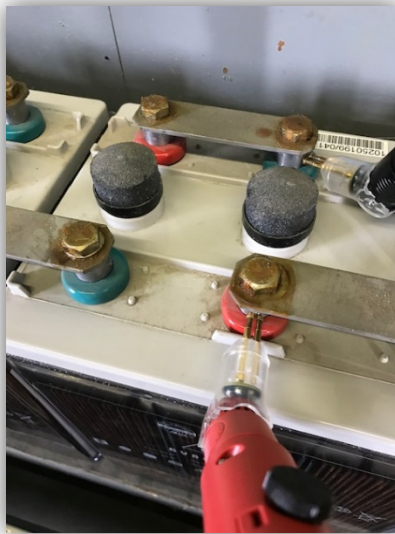
Figure 2. A cell conductance (internal ohmic) test

Figure 2 below shows the initial stage of testing a battery cell. The test probes are placed on the positive and negative posts of the cell. This performs the internal ohmic test, from which the internal conductance and resistance is derived. Next, the servicer leaves the red probe on the positive post of the cell and moves the black probe to the positive post of the next cell, as shown in Figure 3. The test set then performs the intercell resistance test.

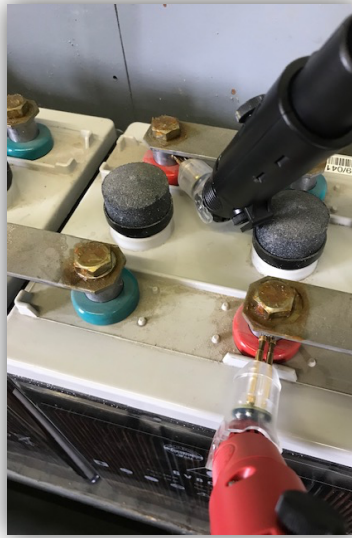
Figure 3. An intercell connection test

The intercell resistance is a calculated value. The tested resistance found during the internal cell test is subtracted from the resistance found during the intercell connector test. What remains should be the resistance of the intercell connector.

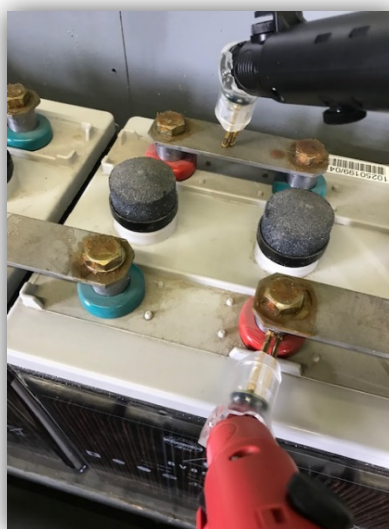
Figure 4. The incorrect intercell connection test

However, this particular servicer was performing his intercell connector tests as shown in Figure 4. As can be seen, the servicer performed the intercell connection resistance test with the black test probe on top of the intercell connector, instead of on the positive post of the next cell. This resulted in an entire connection point not being tested (Figure 5).

The net result of this servicer's incorrect test procedure was that the intercell connection resistance was not tested. In fact, for every connector of every cell of every battery of every year that this servicer tested batteries, these connection points were not tested. Ultimately this meant that for every NERC applicable battery the servicer tested, multiple violations had potentially occurred.

Immediately, the local supervision had every battery re-tested using the correct procedure. These tests did verify that the intercell connections were not at the Warning level. The supervisor over this region also looked at other test values to determine what other batteries at other substations might have been affected. Since this servicer was one of the more experienced persons in the field, he had been used to train newer employees for a number of years. It was feared that his incorrect testing procedure may have been taught to others. There were other batteries of concern, and all suspicious batteries were retested within the next few months.

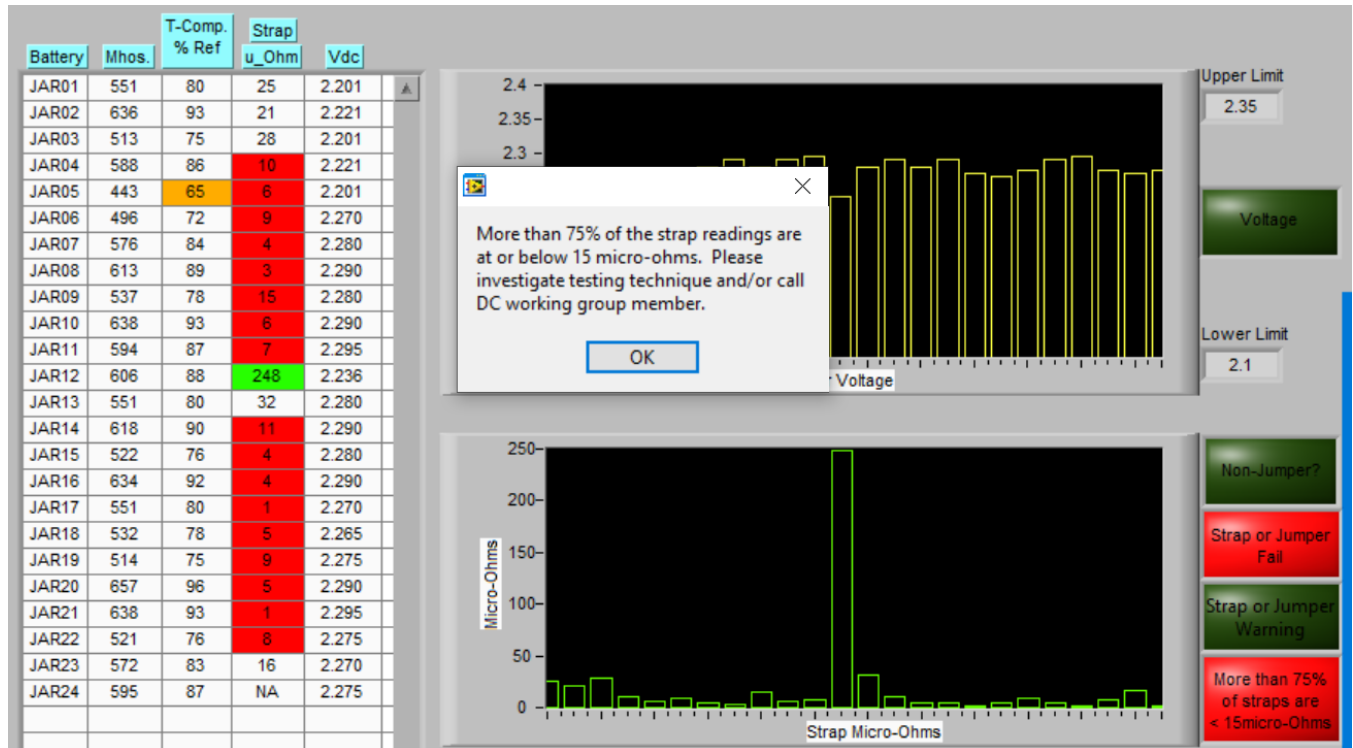
Figure 6. An example of low intercell connectors being flagged

The software that automatically evaluates the test data was modified to include a flag for low intercell connections. Figure 6 shows an example of a battery string with low intercell connector values that has been flagged. If found, the reviewer would have to comment on if a problem actually existed. Also, all field engineers were trained on this incident and made aware of appropriate test values.
