BATTERY EXPLOSION OR BATTERY RUPTURE

HOW TO RECOGNIZE THE DIFFERENCE

Peter J. DeMar
Technical Advisor
Battery Research and Testing Inc.
Oswego, NY

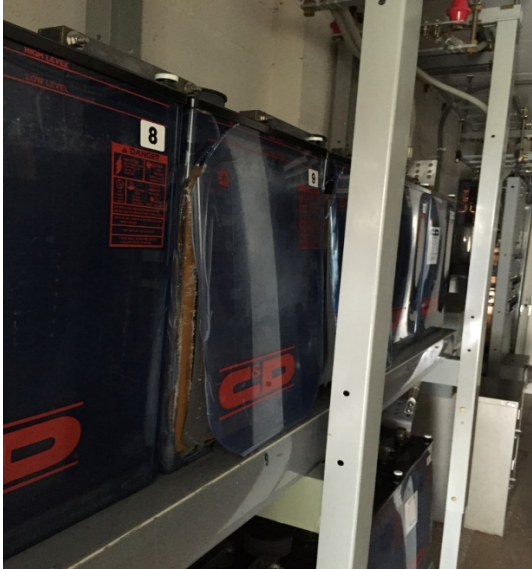
Figure 1. Ruptured cell caused by electrolyte freezing, bottom pushed out, side still connected to the cover, no violence displayed, parts pretty much intact but separated

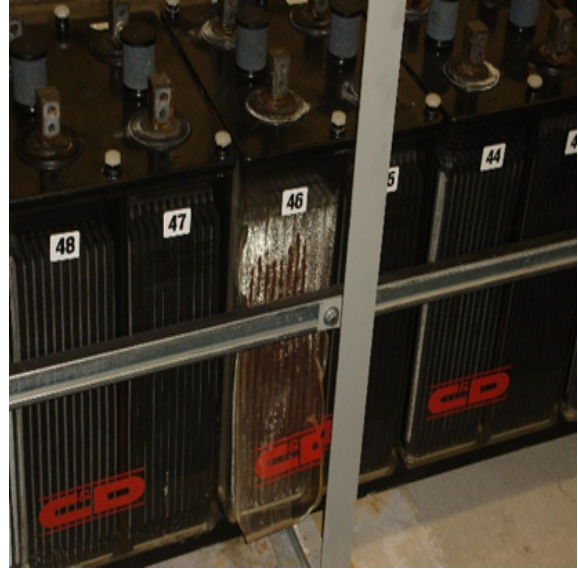
Figure 2. Ruptured cell, cause unknown, side is still attached to the cover, no parts ejected, no violence displayed, parts intact but separated

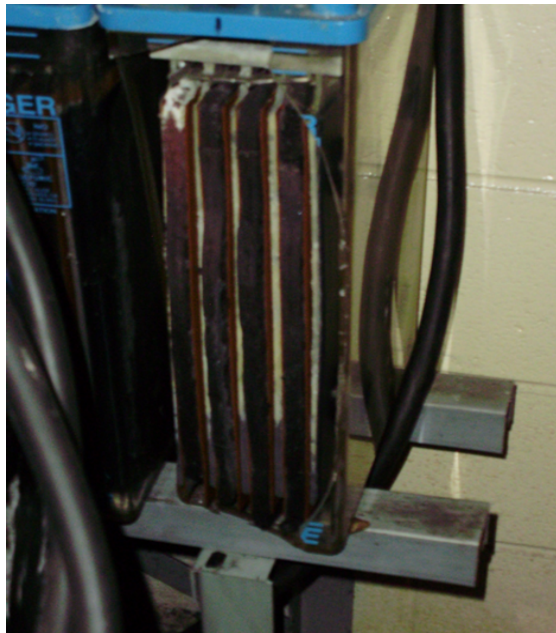
Figure 3. Ruptured cell, cause unknown, most of front missing, but uppermost portion is still attached to the cover, not caused by an explosion, no violence exhibited

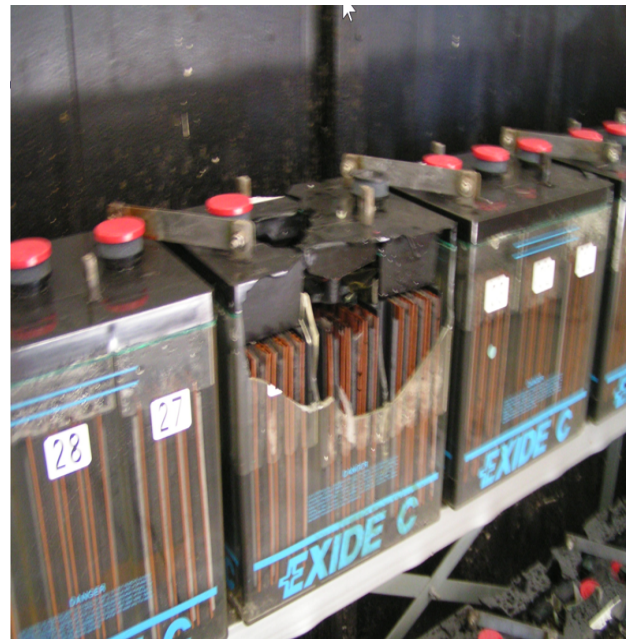
Figure 4. Explosion, damage propagated across the 3 cells, electrolyte still in these cells, low levels in other cells, part of cover and center vent missing, explosion originated in head space, damage limited to upper portion of cells, notice violence of event

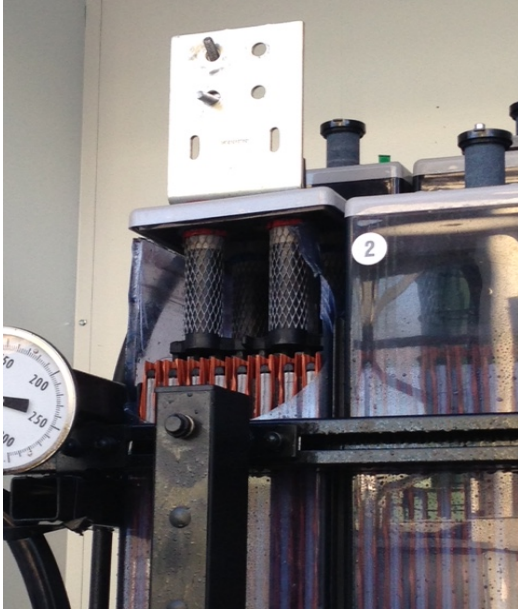
due to the cover being forced upward. Figure 5 shows the cover separated upward from the sides.

Figure 5. Explosion, upper front of jar missing, cover separated from the sides, damage is limited to the upper area of the jar, section of the side of the jar visible above side rail, electrolyte still in jar, violent event

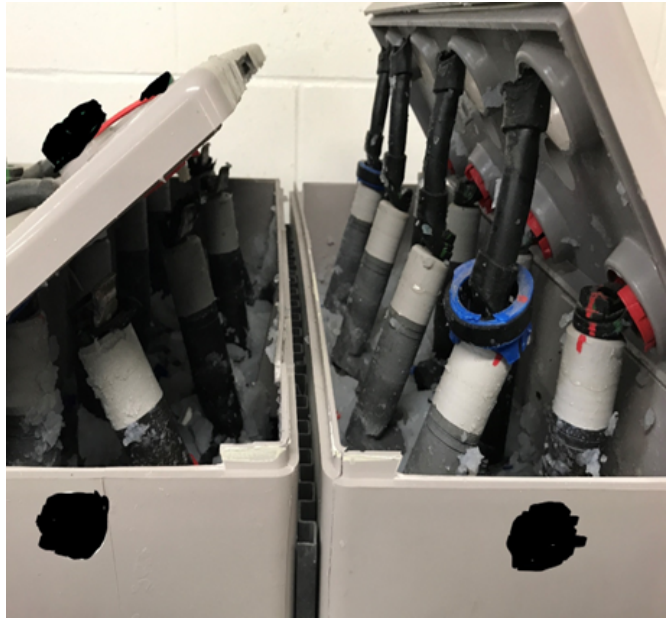
Figure 6. Explosion in VRLA string that occurred during cleaning of the covers with an item that created static, not VLA but it does show how dangerous static can be, and how violent an explosion in the head space of any type cell can be, ESD was the ignition source

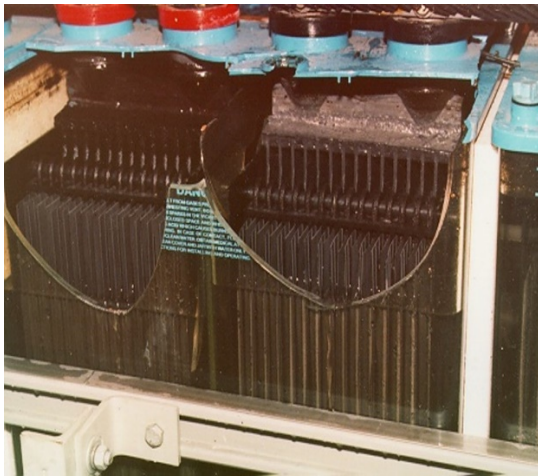
Figure 7. Explosion, cover and sides separated, pieces of side and cover missing, electrolyte still in cells, damage occurred in the upper portion of the jars as occurs in all cells that explode, violent action

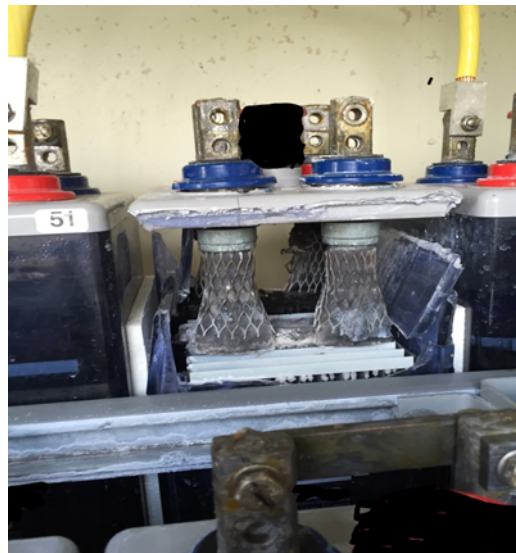
4. That both of the sides have plastic missing confirms an explosion. This is a violent action.
5. That a post seal is elevated indicates that the cell cover was forced upward by the sudden expansion from the explosion. Figure 8 shows how the external post identifiers can be elevated

Figure 8. Explosion occurred during discharge test, nodular corrosion which is visible on the right rear positive post caused that post to open which created the arc that ignited the gas, as always with all cell explosions the damage is limited to the upper area of the cell, violent action

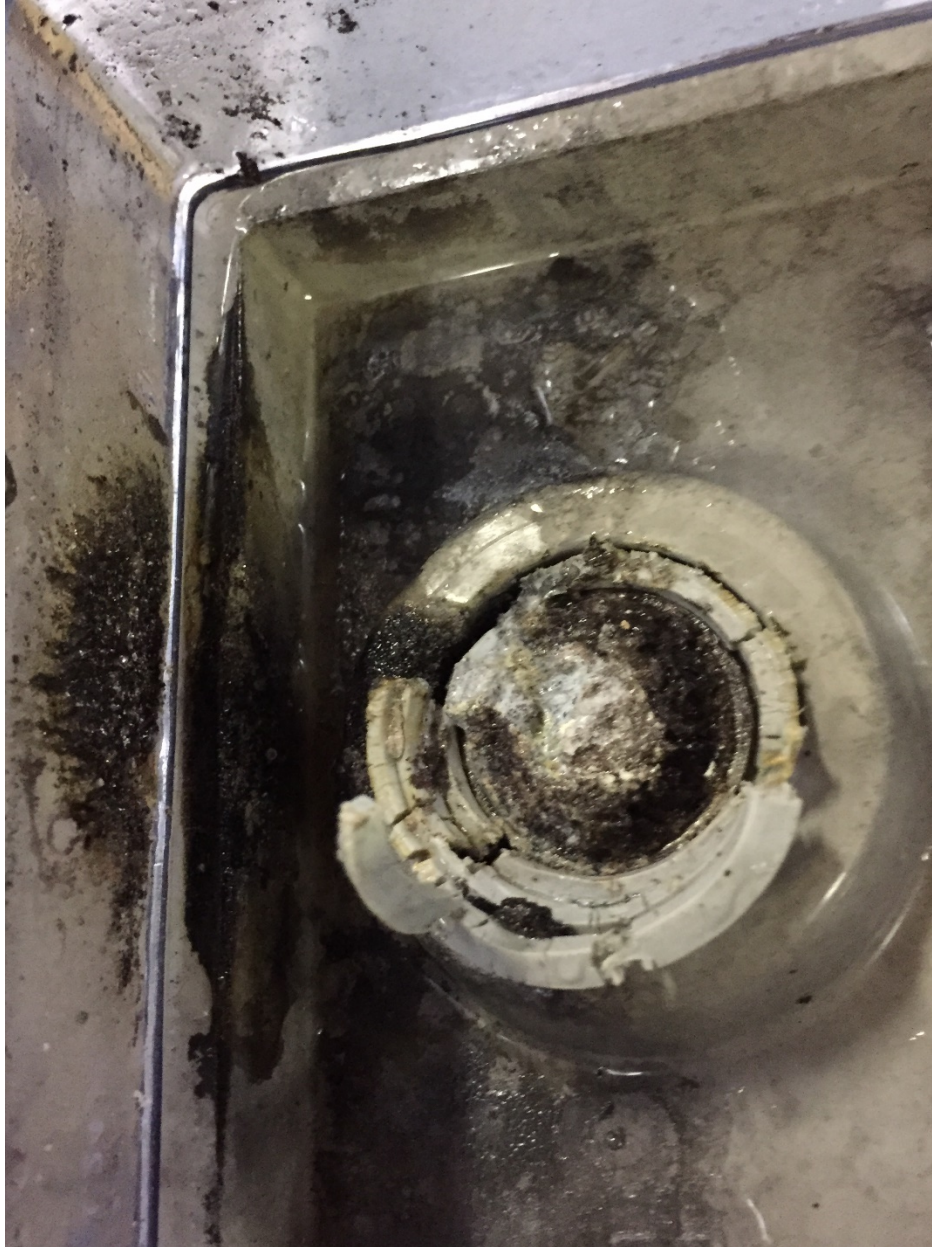
Figure 9. This positive post melted apart under load during first seconds of the unit trip. Notice metal splatter marks on bottom of this cover and side of jar. This cell DID NOT explode, because the mixture of gasses in the head space was not of the right combination that an ignition source could ignite it. The root cause failure investigation determined that nodular corrosion that had gone undetected during battery inspections was the cause of this battery failure. This battery had passed a recent discharge test, but because the discharge test was of a longer duration and lower current and did not include the inrush currents that would be required of the battery to support those instantaneous loads, this was not detected. If a modified performance test had been performed this would have been discovered during a planned outage instead of when the plant was operating. The generator required a rebuild, which as all involved in the utility industry understand, equals big \$\$\$\$ repair costs, plus the lost revenue while the rebuild is being performed. Not a good day for the home team.

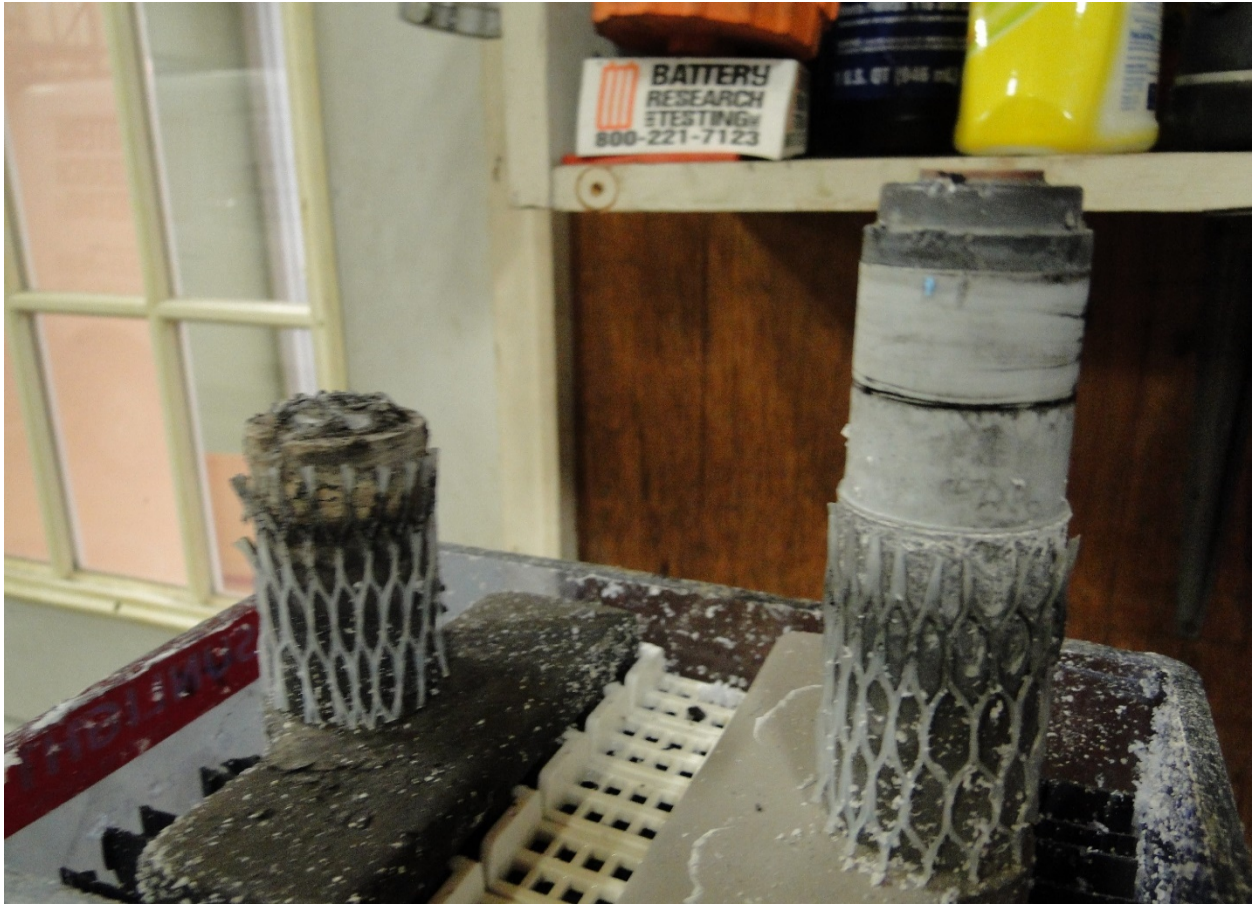
Figure 10. Lower portion of the positive post from the picture in Figure 12. Following the on-site portion of our root cause investigation, the cell that failed open, as well as other cells from the string that were identified as having advanced nodular corrosion issues, were replaced and those cells were sent to our facility for dissection. This picture was taken on one of the work benches. As can be seen the negative post and post seal is in a normal condition, and that the positive post acted like a fuse and simply melted apart. This incident occurred in Chile, and as an FYI, all the batteries and battery rooms at the four plants at this site, were spotless.
