DC PLANT MODIFICATION MISHAPS (AND HOW TO AVOID THEM)

Dan McMenamin
Dan McMenamin and Associates, Inc.
West Deptford, NJ

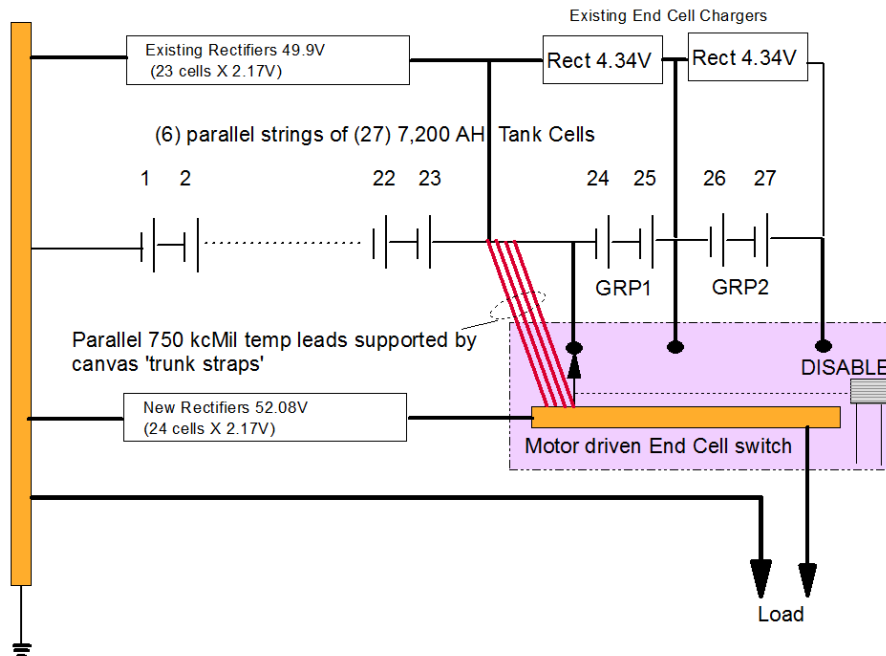
Figure 2: Interim modification of the 302A Plant

Among the first steps in the modification, a fuse was removed that disabled the End cell Switch. Then, several 750 Kcmil copper conductors were run as shown in Figure 2. These conductors were considered temporary and were supported by canvas shipping straps.

Approximately forty-seven minutes into the midnight work shift, all the existing 49.9 Volt rectifiers shut down suddenly. Because the End Cell Switch was disabled the bus voltage went to something less than 46 Volts (23 cells times 2 V, minus the coup-de-fouet dip).

By this time, the battery was somewhat discharged and telephone equipment was reacting to the low voltage condition. A critically bad decision was made to reactivate the disabled End Cell Switch in the belief that doing so would add End cells to the twenty-three. Apparently, the installers didn't realize that the temporary transition cables they had run created a short-circuit path around the End cells. When the End cell Switch moved to the Group 1 position, six 7,200 Ampere-Hour cells times two cells in series dead shorted across the transition cables. The available fault current was approximately 300,000 Amperes. Because of the short-circuit, the plant voltage

didn't increase and so the End Cell Switch immediately moved to the group 2 position and so four cells in series times six in parallel now fed into the transition cabling.

The transition wiring began to burn and the canvas support straps burned through. The transition wiring fell onto the housing of a 480 Volt three- phase busduct thus adding the energized side of the twenty-three cell strings into the burgeoning fault. The sheet metal busduct covers burned through quickly and the conductors then faulted the ac busbars. The ac bus was protected by a 1,600 Ampere circuit breaker that quickly operated but the huge dc fault remained.

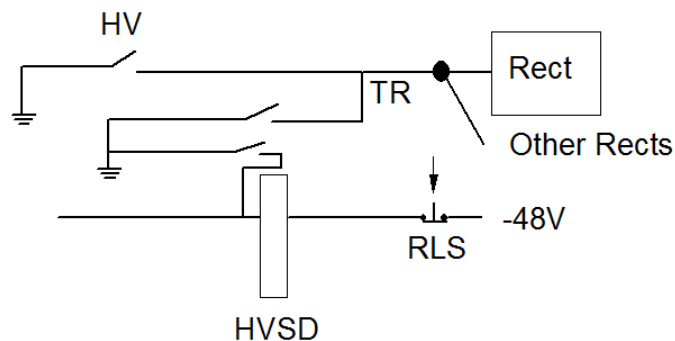
Figure 4: HV Shutdown Circuit

Although unknown at the time, the reason the rectifiers shut down is that a High Voltage Shutdown Relay in the plant controller had operated. All that need be done to correct the condition was to push the ‘Reset’ button on the controller. When operated, the HVSD Relay, applies Ground to the TR leads to each rectifier which in turn, causes the rectifier to shut down. Absent that bit of knowledge, the installers checked the rectifiers for ac power and other conditions that might prevent their operation. At some point, the installers turned on the new 52.8 Volt rectifiers but none of them started because they too had Grounded TR leads from the plant controller HVSD circuit.

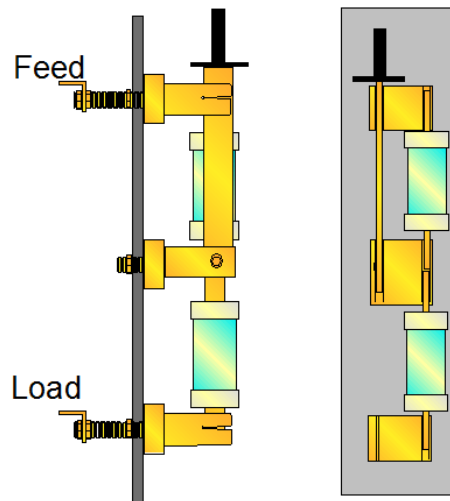
Figure 5: Knife Switch Type Switch & Fuse Unit: Fuses are typically 250 to 600 Amps

With extreme levels of current raging from the battery, the hard-rubber battery containers began to melt and leak electrolyte onto the floor. By then the facility was evacuated. The fire department arrived. Not understanding the actual cause of the fire, they tried operating the switch and fuse units to disconnect the telecommunications equipment load in the mistaken belief that deloading the battery would suppress the fire.

Because they didn't understand switch and fuse units, such efforts were futile. As may be seen in Figure 5, a switch and fuse unit comprise two fuses connected in series with either one of them shunted by a switch. The purpose of this design was to permit either fuse holder to be bypassed for routine maintenance. When firemen operated the switch from one position to another, nothing changed in terms of connected load.

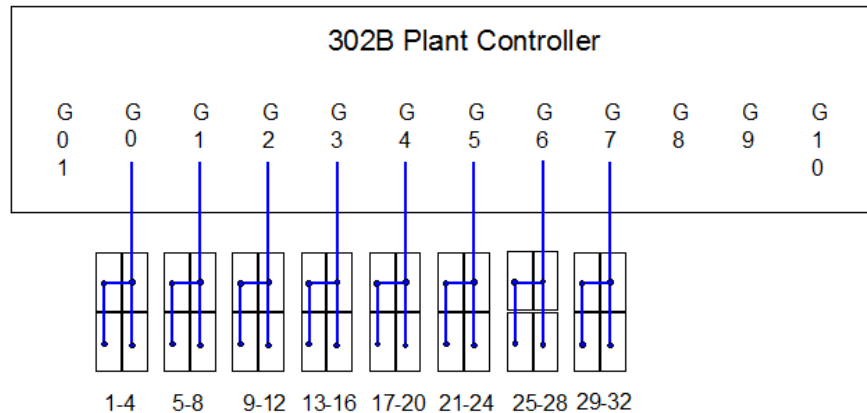
Figure 6: controller wiring modification done at the time

The relay type plant controller is not capable of so many rectifier units and so the manufacturer's engineers specified that the control leads for groups of four (4) 200 Ampere rectifiers be multiplied together as depicted in Figure 6. Accordingly, the thirty-two rectifiers appeared as eight (8) 800 Ampere units to the controller.

Not long after the replacement was completed, the plant began to behave strangely. The aluminum busbars began to vibrate with the whole assembly shaking approximately a quarter-inch (6.4mm). Additionally, a 20 Hz sinewave at 2V peak-to-peak developed on the dc bus and many relays in telecommunications systems began chattering at a 20Hz rate.

So much magnetic flux appeared on the bus that the steel bolts that clamped together layers of busbar, a length of 5/8-inch threaded rod (roughly 5 pounds (2.3 kg)) easily hung from a bolt head. Further, some technician's wristwatch movements became damaged by magnetism.

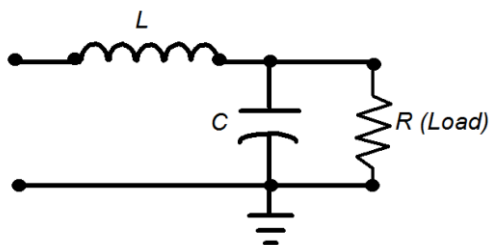
Figure 7: Rectifier Output Filter (also a resonant tank in the case under discussion)

Each rectifier had an L/C type output filter assembly (Figure 7) and with so many rectifiers in parallel the filters took on unusual properties. Capacitors in parallel tend to add in their value. For example, three (3) 30,000 microfarad capacitors in parallel add to produce 90,000 microfarads of capacity. Inductors in parallel tend to divide so that three, 18,000 microhenry inductors in parallel equal 6,000 microhenries. With some thirty-two rectifiers in parallel on a bus, the parallel output filters behaved like a resonant tank circuit with the tank's Q factor being determined by the small amount of resistance in the circuit. For a parallel RLC circuit, the Q factor is the inverse of the series case: $Q = R C L = R \omega 0 = \omega 0 R C$ Consider a circuit where R, L and C are all in parallel. The lower the parallel resistance, the more effect it will have in damping the circuit and thus the lower the Q.

In other words, this dc power plant became a very expensive 2 Volt peak to peak, 20 Hertz, 6,000 Amp oscillator that also happened to feed telecom transport equipment.

Like most pulsed rectifiers, these units used firing boards to pulse the control leads of triacs in the voltage regulation circuitry. The input impedance to the firing boards used was somewhat high. The firing boards were reacting to the resonant tank behavior of the paralleled output filters and imposing the 20 Hertz sinewave onto the dc bus. The solution was to add a small capacitor to each rectifier to detune the firing board and sufficiently reduce its frequency response.

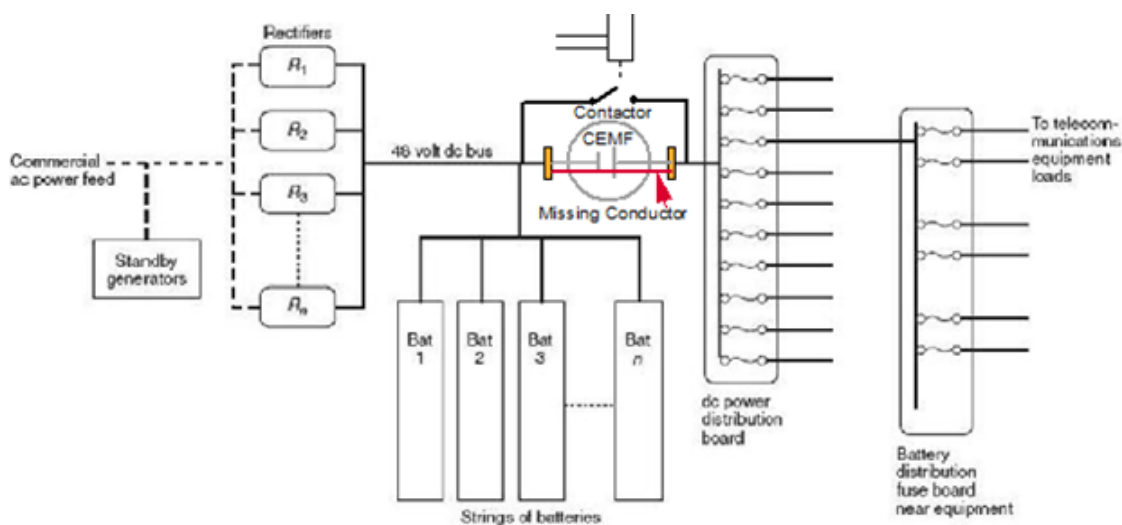
Before modification, the dc plant had an electrochemical Counter-EMF cell to reduce the dc voltage to the telecommunications equipment while on float operation (Figure 8). During a battery discharge condition, a large contactor would operate to shunt out the Counter-EMF cell in order to apply the full battery bus voltage to the load. During the modification the Counter-EMF cell was removed and the installers were supposed to run a short run of 750 Kcmil power wire between the splice plates where the Counter-EMF cell had connected.

Figure 8: Block diagram of a 110 type plant depicting the CEMF cell that was removed but not bypassed.

During an investigation of the incident it was learned that the conductor intended to bridge the removed CEMF cell was somehow omitted. The contactor that would normally short-out the CEMF in a battery discharge was in a normally operated state because the plant Float voltage had been raised. When commercial power failed momentarily, the rectifier shutdown and restart caused a bus voltage ‘bobble’ that caused the CEMF contactor to fall to a non-operated state denying dc to the telecommunications systems for the brief time until it reclosed. The removal and reconnection of dc caused the electrolytic capacitors in the telecommunications systems to discharge and then quickly recharge. Excessive recharge current to the electrolytic capacitors caused their upstream fuses to operate.

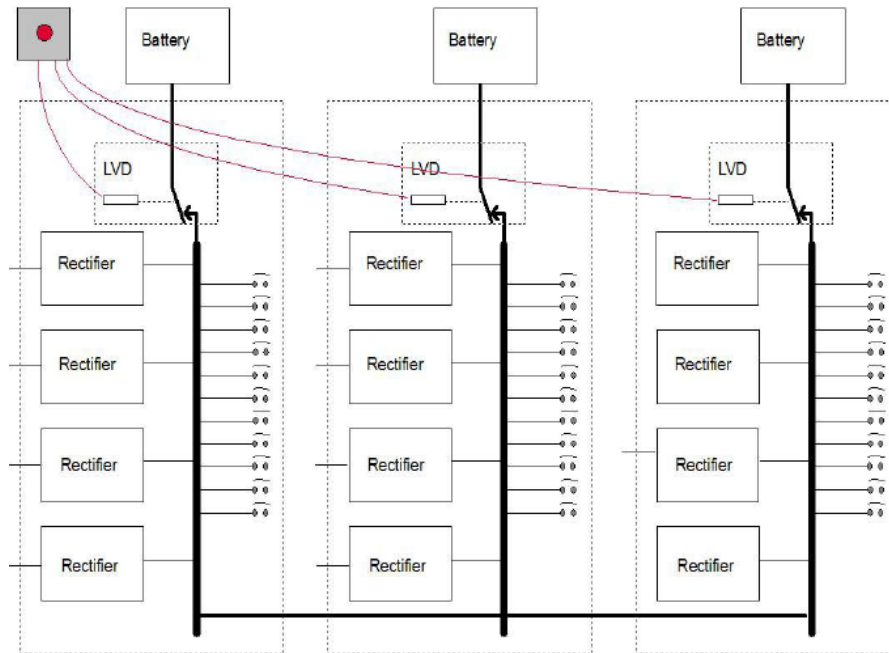
A central office was initially equipped with a three (3) bay Distributed Architecture power plant. The contracted engineer who did the initial job found him/herself confronted by a local ordinance^{2v} that required a Battery Disconnect Switch external to the building. In order to comply, the engineer ordered the plant with a Battery Low Voltage Disconnect (LVD) feature (a disconnect contactor). On installation, the engineer specified that the low voltage controls be eliminated and external wiring provided to a switch in a Riser Room (Figure XX).

As the telecommunications load grew, another engineering firm won the contract to add bays to the original plant. This firm apparently didn’t know about the requirement or the modification and therefore didn’t order the bays equipped with the LVD option. That job and a later one went in without LVDs. The shortcomings of this predicament are:

- The Fire Department believes that they can disconnect all battery strings with a single button and they cannot.
- The non-standard wiring creates troubleshooting difficulties because the undocumented as-built wiring is different.
- Because the circuitry is not alarmed, the EPO switch could be operated and some battery string sitting on open circuit for an indeterminate period. In such a case, the load on the remaining battery strings could overload the inter-bay equalization links and cause them to overheat and perhaps burn open.

Figure 9: Local modifications to a Distributed Architecture dc power plant to make the LVD function as an EPO.

The matter was resolved by meeting with the local fire department and showing the large territory that would be without communications if the EPO switch was activated accidentally or with malice and the many fire detection and protection arrangements for the facility. Once they understood the issues, the fire professionals approved a variance to the county requirement.
