DC PLANT MODIFICATION MISHAPS (AND HOW TO AVOID THEM)

Dan McMenamin
Dan McMenamin and Associates, Inc.
West Deptford, NJ

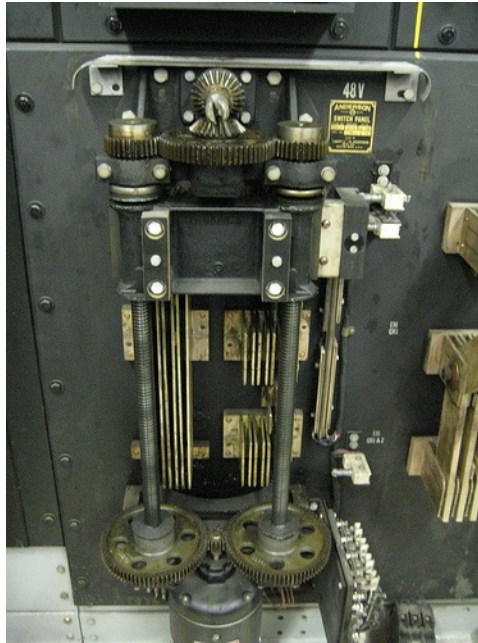
Figure 3: A typical End Cell Switch (cover removed)

By this time, the battery was somewhat discharged and telephone equipment was reacting to the low voltage condition. A critically bad decision was made to reactivate the disabled End Cell Switch in the belief that doing so would add End cells to the twenty-three. Apparently, the installers didn't realize that the temporary transition cables they had run created a short-circuit path around the End cells. When the End cell Switch moved to the Group 1 position, six 7,200 Ampere-Hour cells times two cells in series dead shorted across the transition cables. The available fault current was approximately 300,000 Amperes. Because of the short-circuit, the plant voltage

didn't increase and so the End Cell Switch immediately moved to the group 2 position and so four cells in series times six in parallel now fed into the transition cabling.
