MYTHS AND PERFORMANCE PROBLEMS IN TELECOM NETWORK POWER

Dan McMenamin
President
Dan McMenamin and Associates, Inc.
Croydon, Pennsylvania 19021

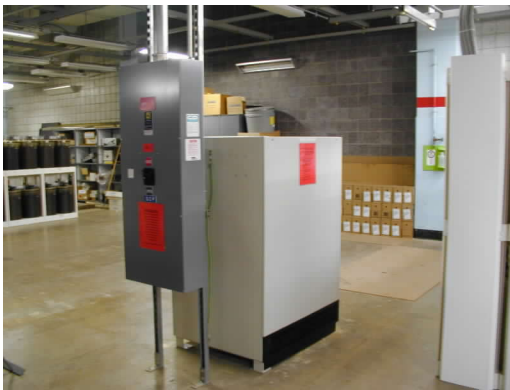
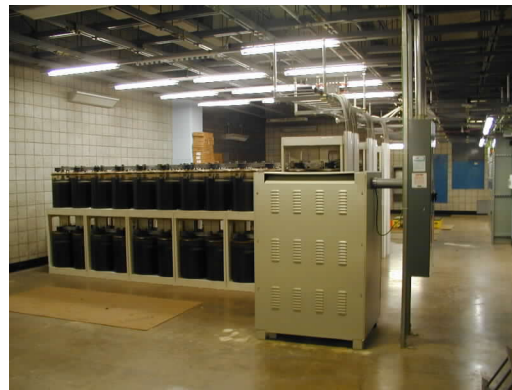
Figures 1 and 2. Cabinetized VRLA batteries share a spacious power room in this UPS application.

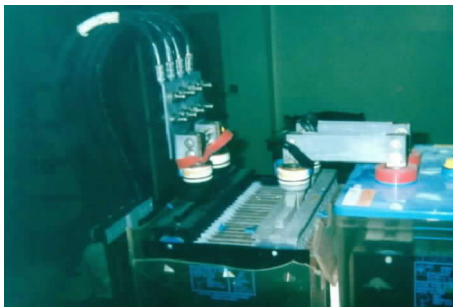
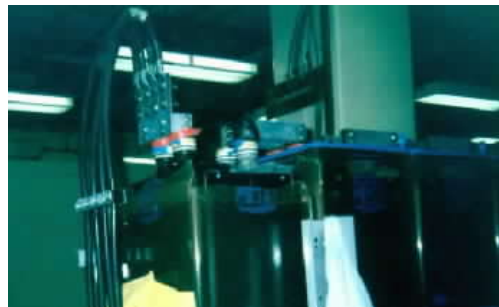
Figures 3 and 4. Explosion damage.

The most dramatic battery failures we've experienced, for example, put only a few ounces of electrolyte on the floor and do not justify spending the cost of a containment. The two most dramatic events in a flooded cell are meltdown and explosion; yet, in our experience, none of these has resulted in significant spillage.

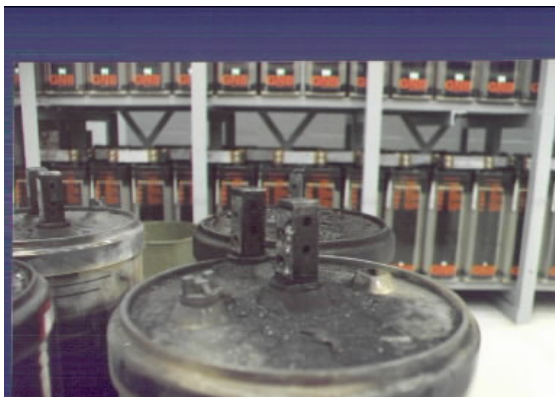
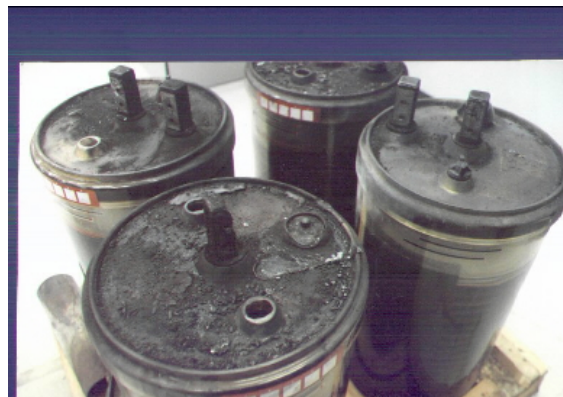
Figures 5 and 6. Post meltdown damage.

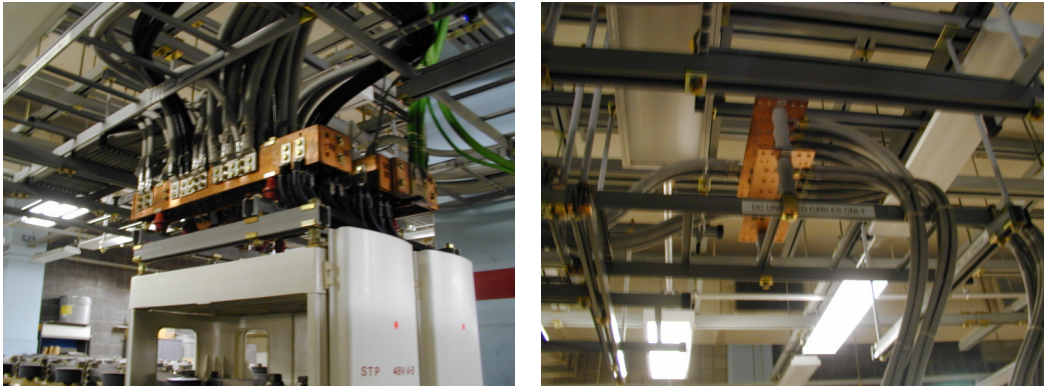
Figures 9 and 10. Battery buses.

A number of preventable accidents and telephone service interruptions have occurred due to exposed bus-work. There is no good reason to leave a bus exposed, and guards or covers would help to prevent these. Such covers should be made of flame retardant insulating materials that will pass the UL 94 flame test with a score of V-0 or V-1. A V-2 rating would not qualify. In the bus-work shown below, it's easy to see where accidents can happen. The bus is unfused, and potentials are very close together when adding or removing large lugs and cables. These physical design issues need addressing to avoid possible injuries and service reliability lapses.
